Appendix A

Photo Logs

Facility Siting General Photolog

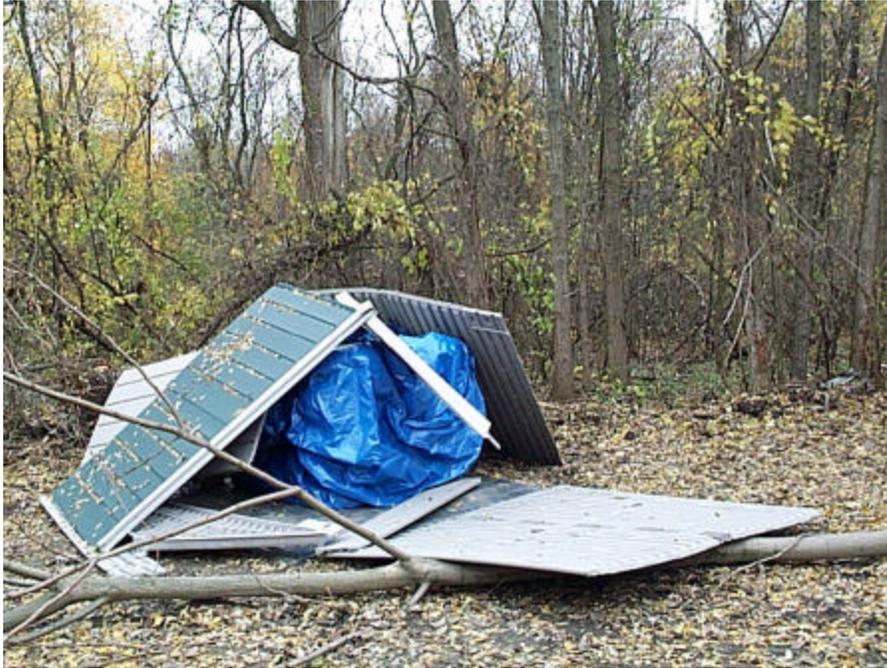
View to north of vandalized drum storage shed at State of NY/First Rensselaer/Marine Management site (11/06/03).

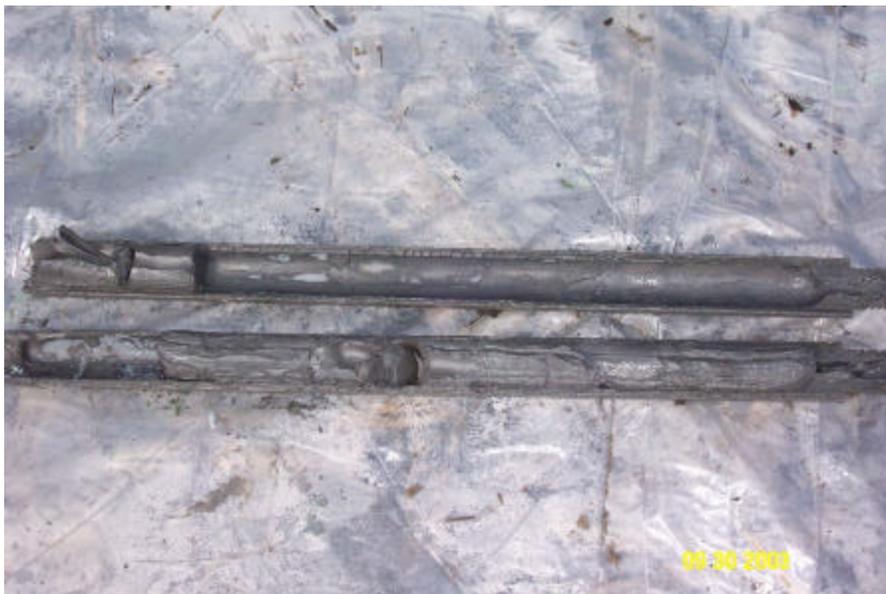
Split-spoon of highly plastic clay, 20- to 22-foot-depth interval from boring EPL-GT02 (09/30/03).

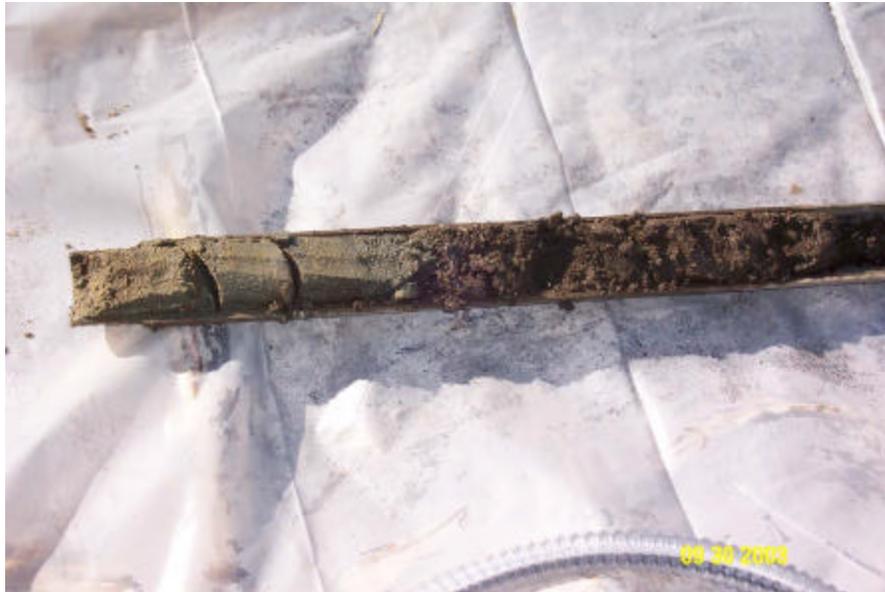
Contact of silty sand overlying well-graded sand at 5 feet BGS, in split-spoon sample from boring EPL-GT03 (09/30/03).

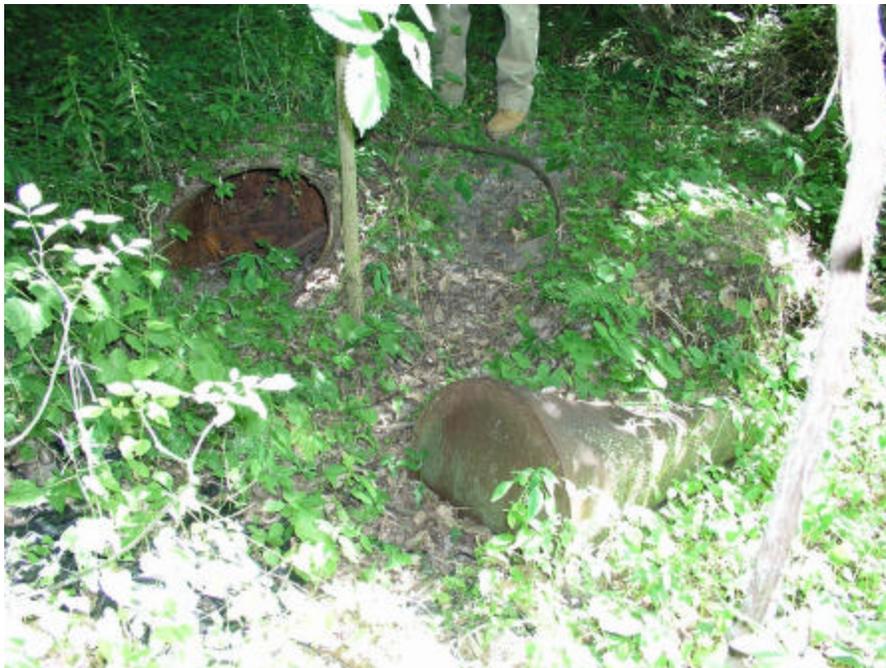
View to south of two of 11 drums in northwest corner of site (07/10/03).

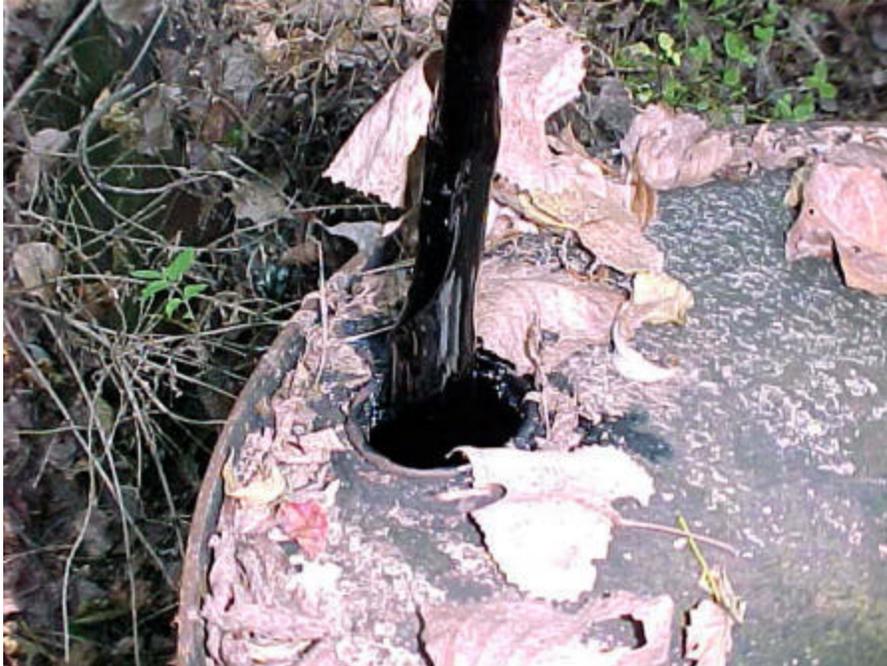
Close-up of black tar-like material from drum in northern drum disposal area (10/09/03).

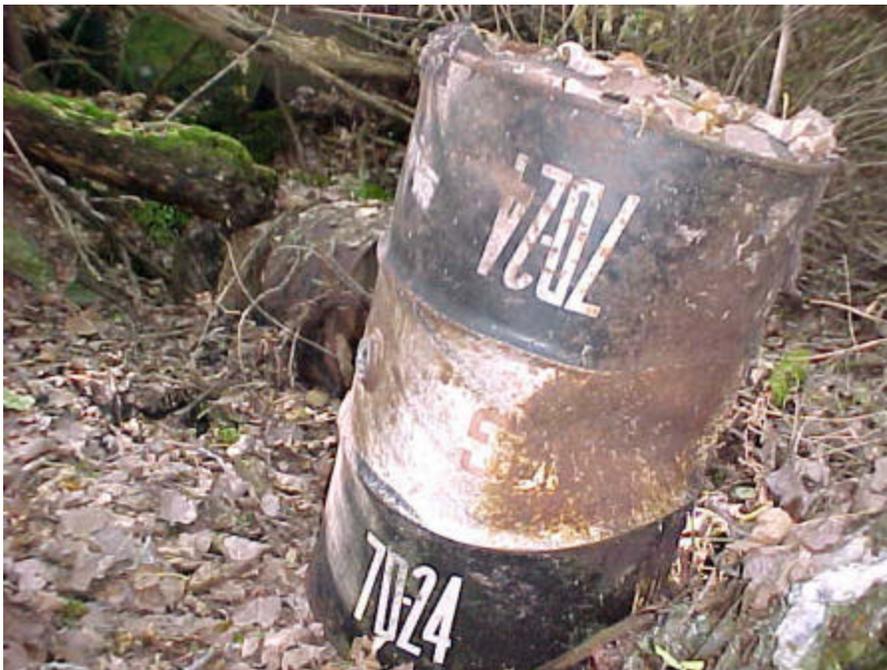
View of drum containing black tar-like material in northern drum disposal area (10/09/03).

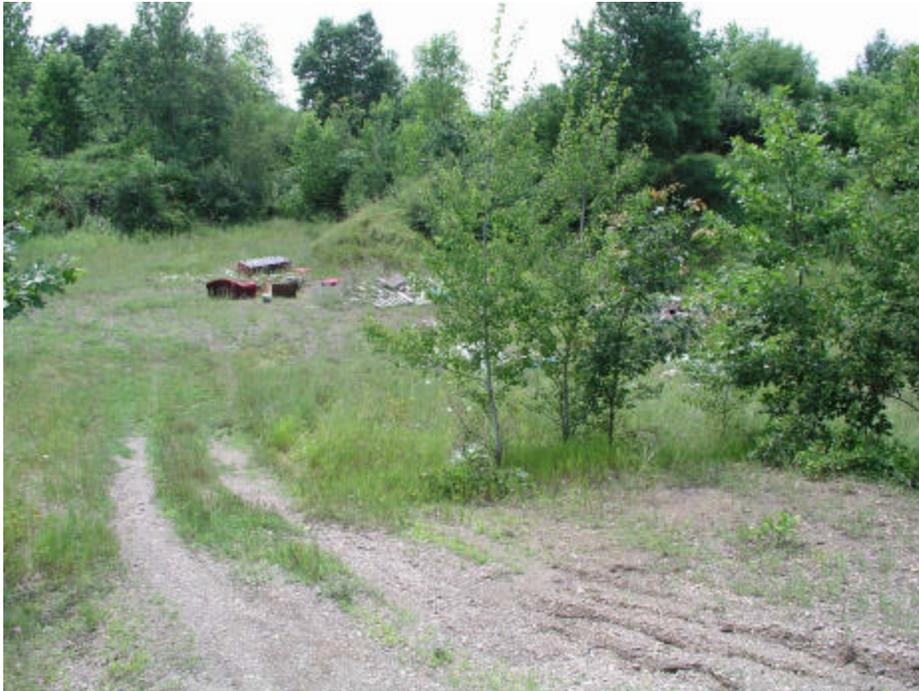
View to west of old gravel pit with debris (07/24/03).

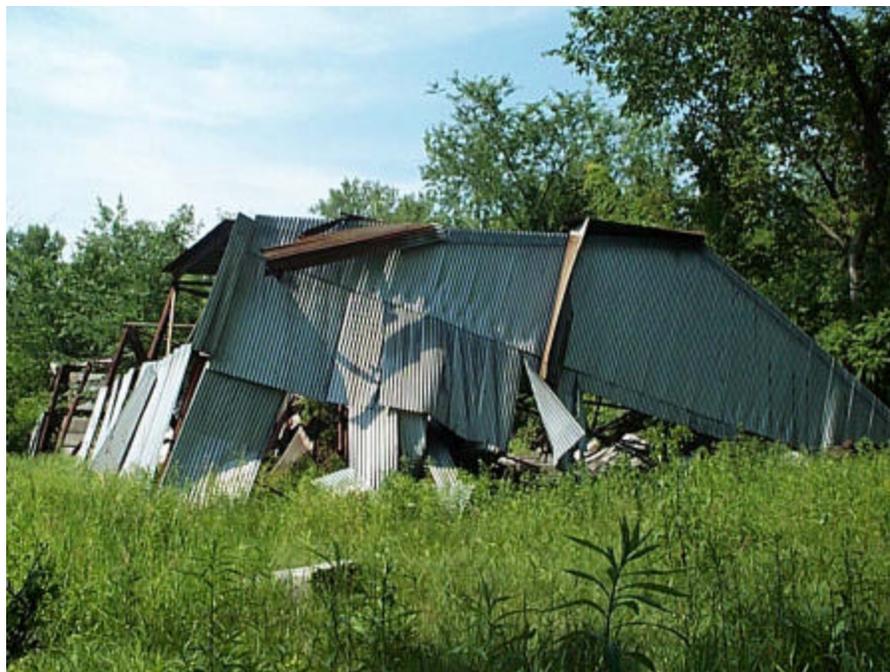
View to west of building destroyed by tornado (near temporary well BBA-GP01) (07/24/03).

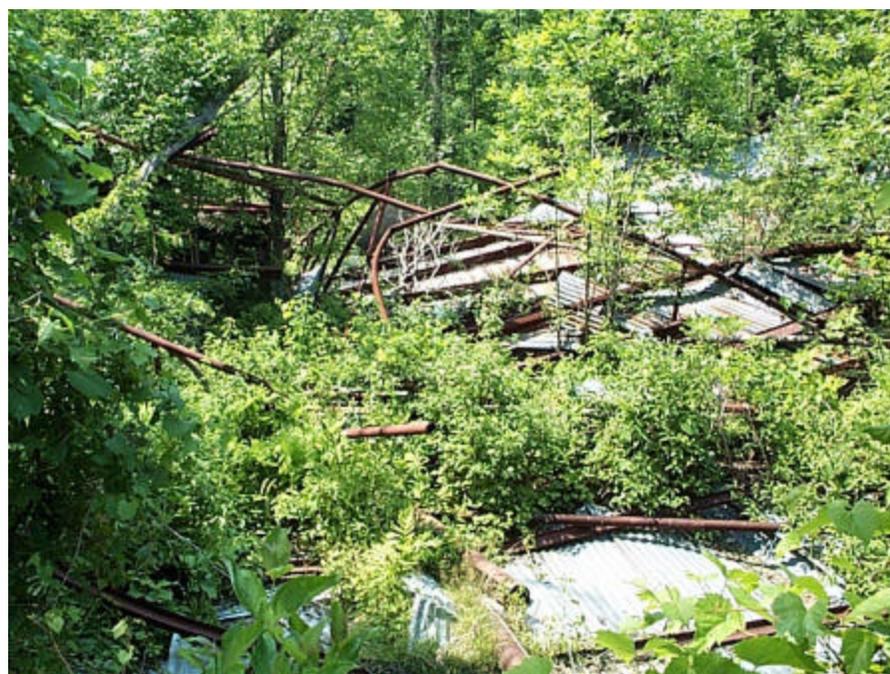
View to west of building destroyed by tornado (near surface soil sample BBA-SS04) (07/24/03).

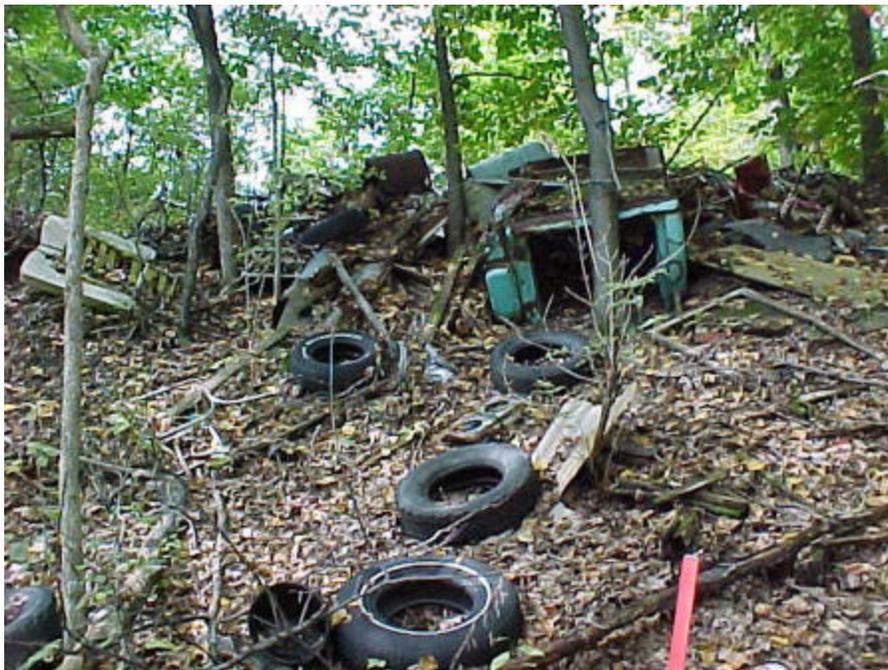
**Tires and other debris at surface soil sample location NCC-SS03
(10/02/03).**

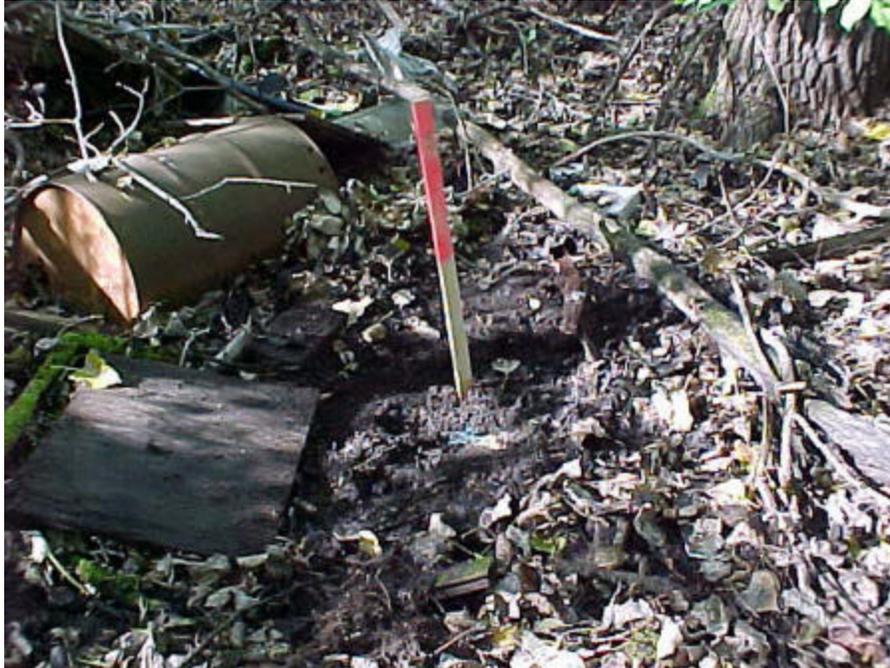
View to north of drum and other debris near surface soil sample location NCC-SS06 (10/02/03).

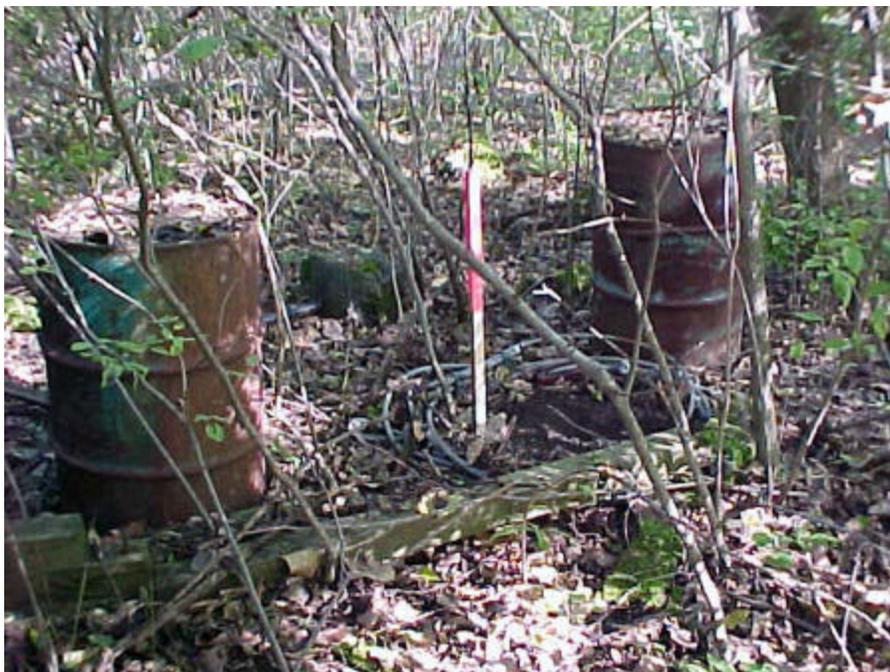
View to south of drums, cables, and debris at surface soil sample location NCC-SS07 (10/02/03).

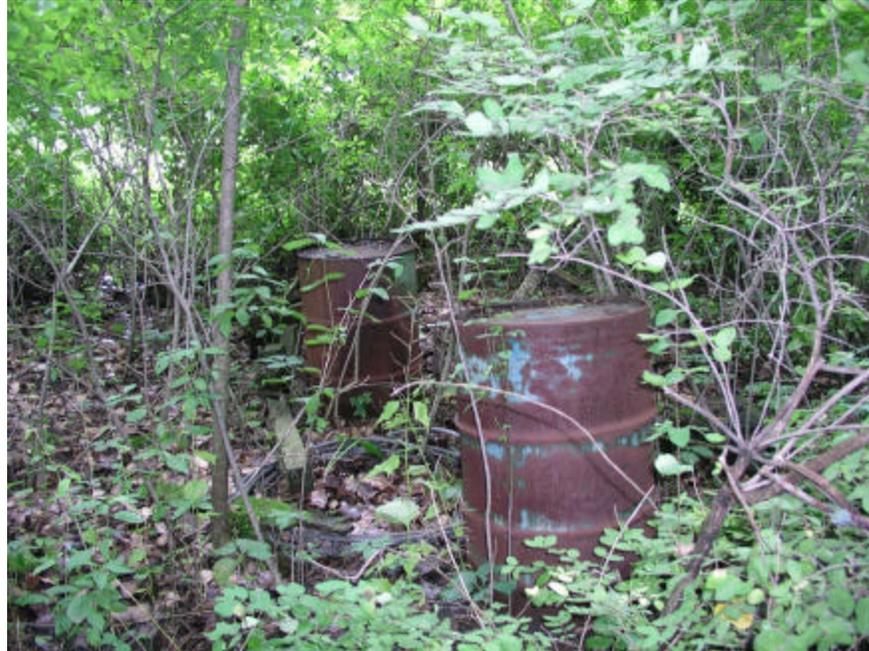
Drums in northern portion of NYS Canal Corp. parcel near surface soil NCC-SS06 (10/02/03).

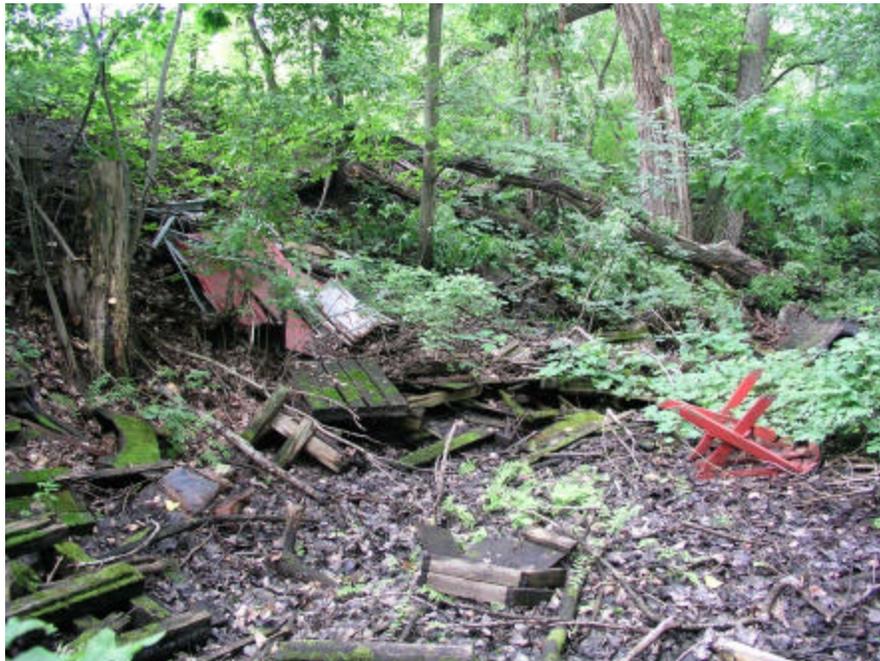
Dump in northern portion of NYS Canal Corp. parcel near surface soil NCC-SS07 (10/02/03).

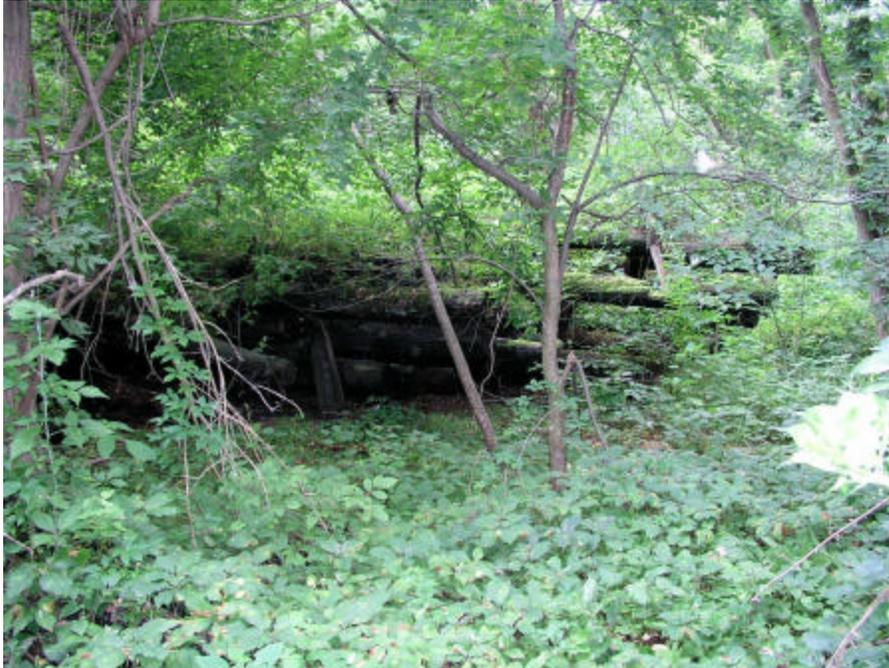
View to north of log pile with iron spikes in some logs (07/17/03).

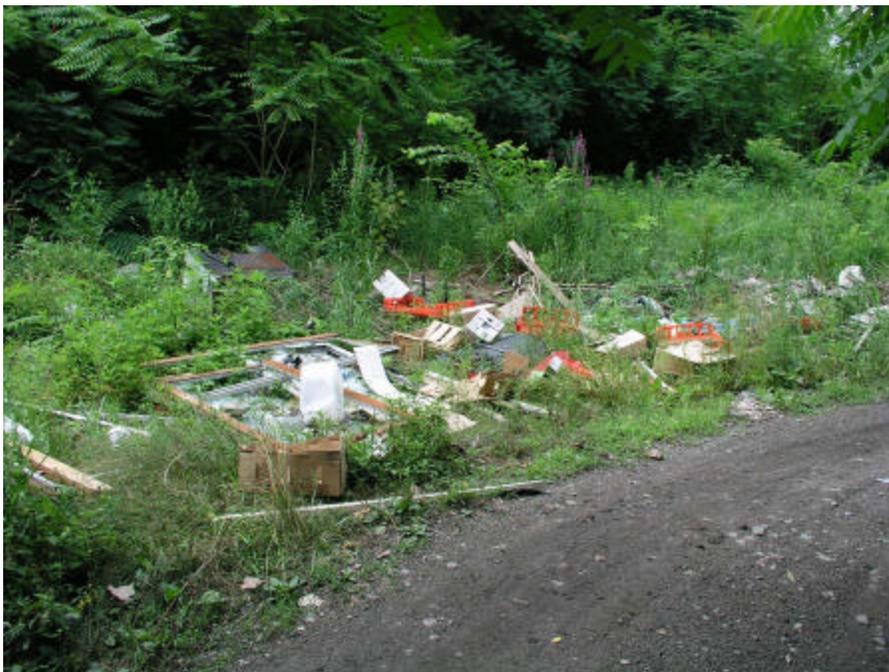
View to south of dumping area adjacent to access road bisecting the site (07/17/03).

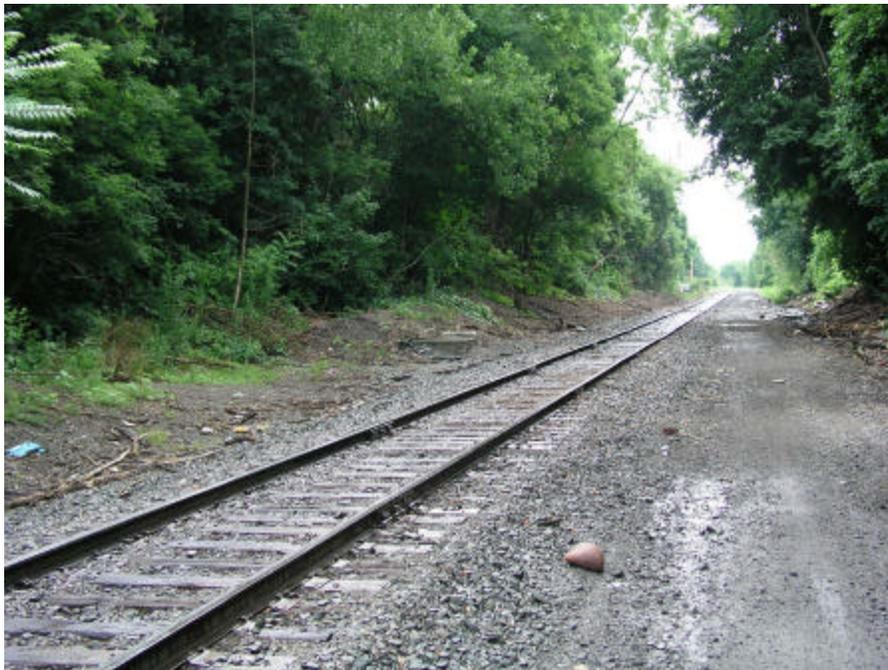
View to north of ash pile along west side of the railroad in the central portion of the site (07/17/03).

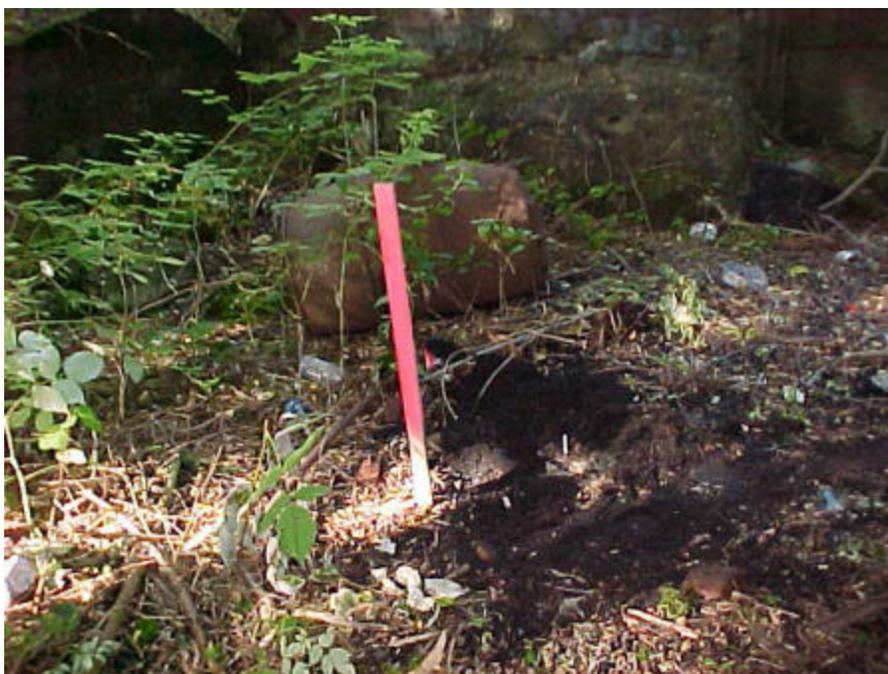
Drum near surface soil sample location MM-SS09 (10/08/03).

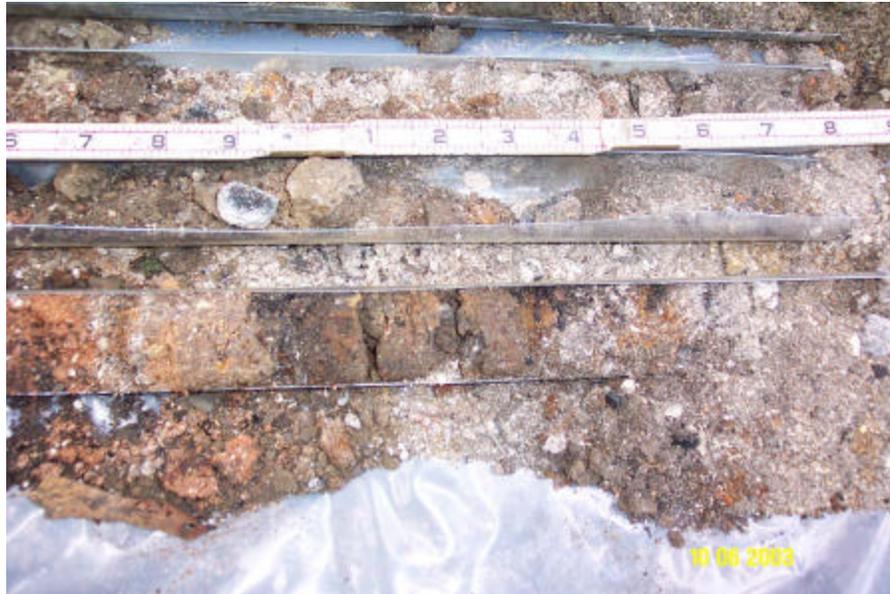
Fill material in Geoprobe soil sample from MM-GP01 (10/10/03).
